AMSTAR ENGINEERING, INC.
Structural/Civil Consultants
707 River Road
Austin, Texas 78734
(512) 263-3661
Fax (512) 263-7916

July 8, 2010

Ref: Structural Inspection
240 Canterbury Dr.
Project No. 1954

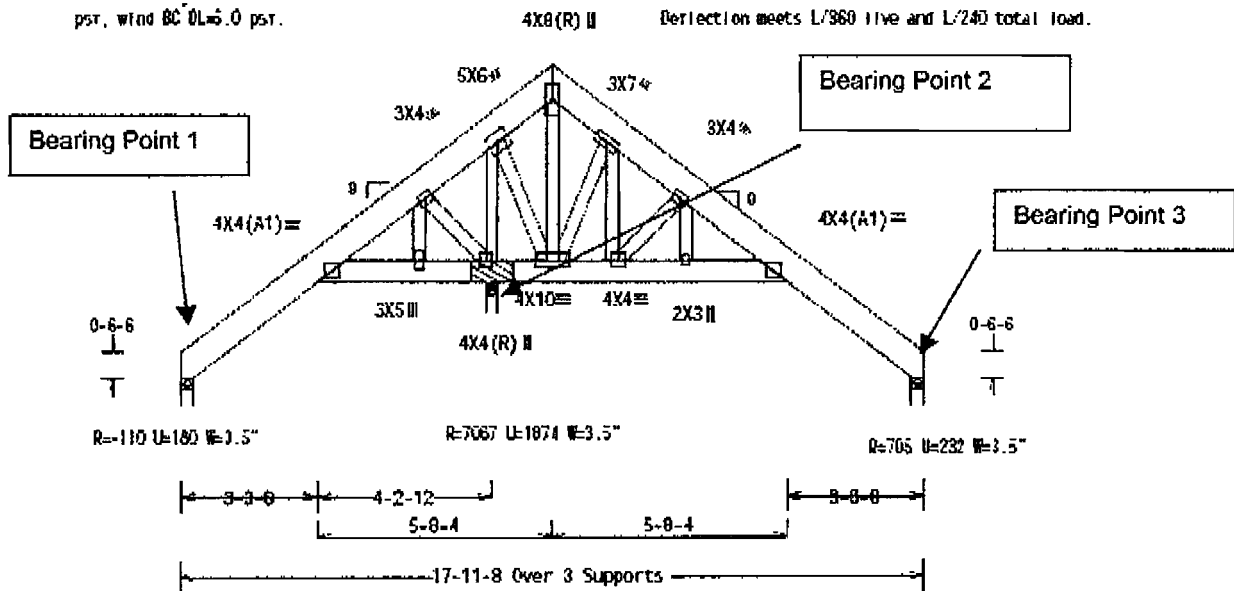
EXHIBIT B

2. Exhibit C has been cut and pasted onto Mr. Copeland's response letter (with Mr. Kampmann's seal removed), and submitted to TBPE very recently as part of his response to your complaint. It is not the "truss repair" diagram. Note the diagram depicts the top portion of a load bearing wall supporting the bottom chord of the truss near the middle of the truss span. That wall represents the interior wall of the bedroom. This particular wall is currently bearing down on the floor truss system at the second floor portion of your house. It is also causing much of the problem with overloading the floor system that MLAW comments on in Exhibit "D". It is also the same diagram that I included in my report, dated November 20, 2008, in which I sought calculations to be provided by MLAW to prove that the truss repair being proposed by MLAW had been designed in accordance with proper engineering standards (Exhibit "F"). Exhibit "C" depicts the existing, unrepaired truss as it sits in your house today and that is continuing to cause damage to the second floor trusses of your home.

this is designed by Alpine. Notice the three supports, specifically R=7067 and U=1874. That represent Live Load and Dead Load respectively and that load lands upon a beam in the floor that loads up a floor truss.

These truss drawings are designed and sealed by Alpine truss and sealed by the engineer responsible for the components.

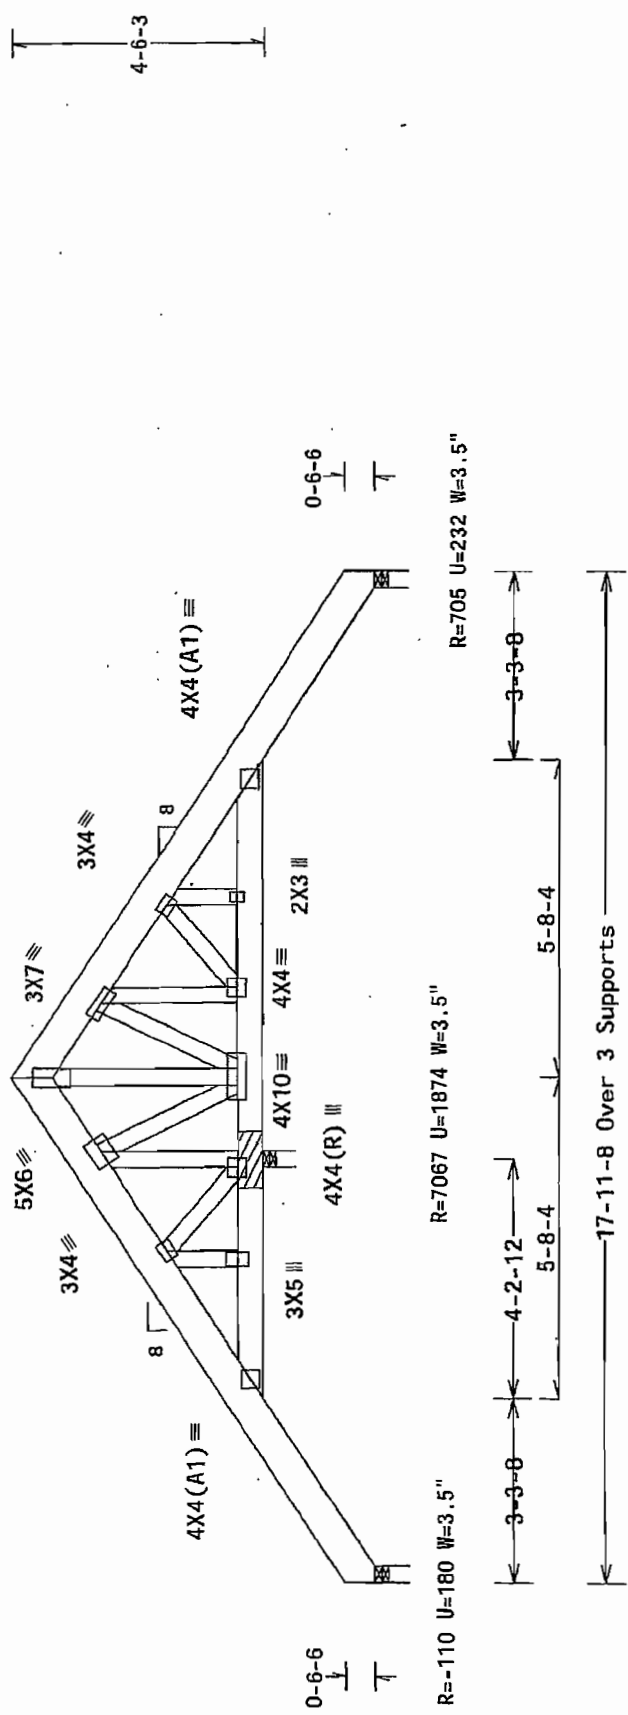
EXHIBIT C
 EXHIBIT 23

1. The existing truss is shown in Exhibit "C" and was PE sealed by Mr. Kampmann on November 3, 2004. The diagram depicts the load bearing wall. Mr. Copeland issued Exhibit "C" and I included it in my November 20, 2008 report as Exhibit 23.

5. When you compare the details of the existing truss in your house (Exhibit C), with the details of Mr. Copeland's truss repair, you can see that many of the connector plates have different sizes, with Mr. Copeland showing 7x8 connector plates near the support points of the truss whereas the existing connector plates are only 4x4. Metal connector plates have metal teeth that mash into the wood and hold the members together – the larger they are, the greater the resistance of the members to being pulled apart. There are other changes to the connector plate sizes. Mr.

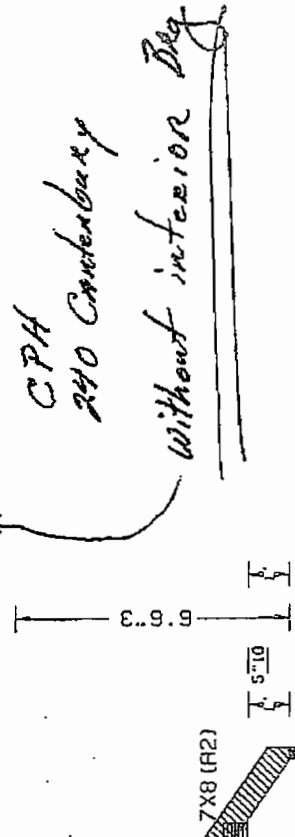
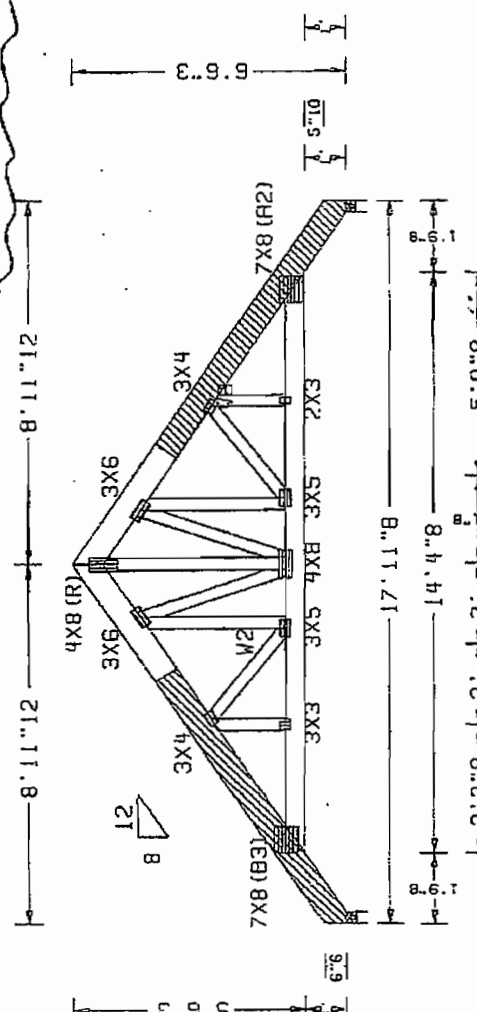
EXHIBIT 25

3. On May 25, 2007, MLAW issued the report containing the repair plan that is shown in Exhibit "E". This repair plan does not have Mr. Kampmann's PE seal and there is no logo depicting Alpine. As presented, it is the work of Mr. Copeland and MLAW. The repair plan is dated May 18, 2007 and was submitted to me in the May 25, 2007 report under seal of Mr. Copeland. This is the detail that I relied on in my report dated November 20, 2008 and is the same detail as Exhibit "25" from my report.

4. Exhibit E depicts both theory as well as a repair. Exhibit E shows that the load bearing bedroom wall acting as a support point has been removed. In actuality, what I understand that MLAW was trying to accomplish was an effort to stiffen up the existing truss and perhaps remove a top portion of the wall, including wall sheetrock, to take this truss load off the middle wall. Engineering statics dictates that this load from the roof has to find a way to the foundation, and so Mr. Copeland's theory was evidently to transfer the loads to the end walls shown at both ends of the truss. In doing this, the truss span becomes longer than originally designed since it no longer has a near-mid-span bearing point and it must span a greater distance from wall to wall. This means that the stresses in the truss are much greater than before and the existing truss must be substantially reinforced or completely replaced. This solution ignored the previous damage that had already been caused to the second floor trusses which certainly benefitted the builder when it provided cost of repairs to your house.

Copeland is calling for a change in size of the connector plates, but provides no calculations to show how he arrived at those sizes. Since the girder truss depicted actually consists of two trusses mashed together, and connector plates are attached on both faces of each individual truss, this repair cannot be accomplished inside the attic as depicted in Exhibit E because the connector plates at the touching faces cannot be reached. Mr. Copeland admits that he is not qualified to perform truss calculations (Exhibit G), yet he applied his PE seal to a report containing Exhibit E. I know that he has pled that others gave him the numbers, but that doesn't matter because you, I and the rest of the general public relied on his seal and it is evident that Mr. Copeland does not know if any numbers are actually correct and he has failed to protect the public.

Simply stated, my opinion is that Mr. Copeland held himself out to you (and to me and others) as being competent in structural analysis, including truss repair analysis, when he issued his May 25, 2007 report and PE sealed his report. Mr. Copeland included Exhibit "E" in that report and, as explained by my July 7, 2008 letter, Exhibit "A" (and hence Exhibit "E") does not comprise a suitable repair.

(1) 2x8x7-6-15 SP #1 scab at right end. Attach scab to face of chord with 10d Box or Gun (0.128"x3" min.) nails @ 8" OC plus additional nail clusters at BRG.: (6), heel: (8), 1st panel point: (4).

(1) 2x8x7-6-15 SP #1 scab at left end. Attach scab to face of chord with 10d Box or Gun (0.128"x3" min.) nails @ 8" OC plus additional nail clusters at BRG.: (7), heel: (11), 1st panel point: (4).
