May 2, 2007

Capital Pacific Homes
12401 Research Blvd, Bldg II, Suite 100
Austin, Texas 78759
Attn: Bart Koonse

RE: Level B Investigation – Initial Foundation Report
240 Canterbury Drive
Belterra Subdivision
Dripping Springs, Texas
Job No.: # 714008000.004

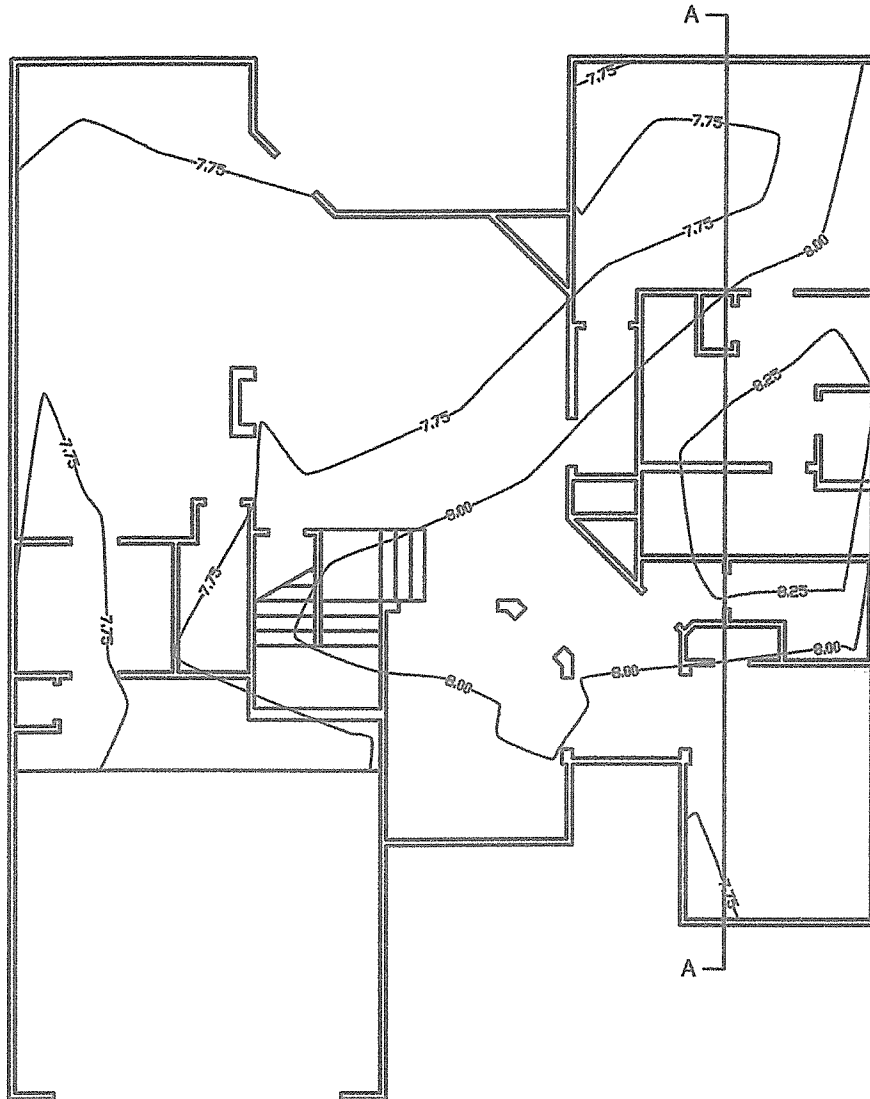
SLAB SURFACE CONTOURS

Foundation Performance: based on our observations and analysis, any distress noted within the home is not an indication of a structural defect in the foundation. Slab surface contours were developed and the maximum deflection ratio derived from these contours (after correcting for tilt) was L/1253. This ratio is well within the accepted industry standard of L/360 as established by, "Guidelines for the Evaluation and Repair of Residential Foundations", available from the Texas Section, ASCE.

The final report will list the deflection of the second level flooring system and any recommendations for remediation, if necessary. As with all foundations, we recommend that a thorough watering regiment be implemented to help maintain a uniform moisture level in the soil around the foundation. This will help alleviate any movement of the foundation due to seasonal fluctuations in rainfall.
