**STATE-SPC SORED INSPECTION AND
DISPUTE RESOLUTION PROCESS (SIRP)
Third-Party Inspection Form**

Date of Report: August 5, 2009

SIRP File # **2299**

Address of Home: **240 Canterbury Drive, Austin, TX. 78737**

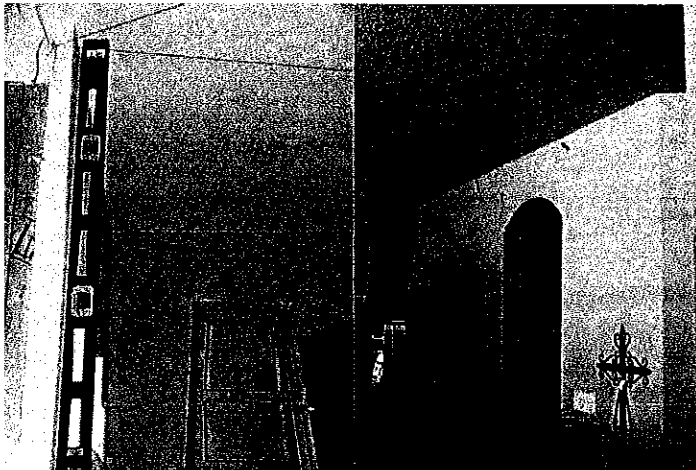
Item # 8 Alleged Defect: 2 walls bowed @ Den

Observations/Tests Performed: As pointed out by the homeowner there is a bow in the wall near the stairs. The bow is in the top two 2' of the wall and tends to bow inward toward the front of the house approximately 1/2" over approximately 24". All indications are that the wall was built this way and bowing did not occur over time or due to

structural weakness. This appears to be a workmanship issue and not a strength issue regarding wall bracing or construction.

The second area pointed out by the homeowner was over the arch opening in the living room against the right side wall. There is a hump in the sheetrock approximately 3/8" out from the wall over 32" measurement parallel along the wall. All indications are that the wall was built this way and bowing did not occur over time or due to structural weakness. This appears to be a workmanship issue and not a strength issue regarding wall bracing or construction.

Since this is a workmanship and materials issue it will not be considered a structural item to be inspected.

TPI: Excluded from inspection for reason: Item is a workmanship and materials issue and out of warranty period for inspection as a construction defect.
