May 25, 2007

Capital Pacific Homes
12401 Research Blvd, Bldg II, Suite 100
Austin, Texas 78759
Attn: Bart Koonse

RE: Level B Investigation – Evaluate Drywall Cracking
240 Canterbury Drive
Belterra Subdivision
Dripping Springs, Texas
Job No.: # 714008000.004

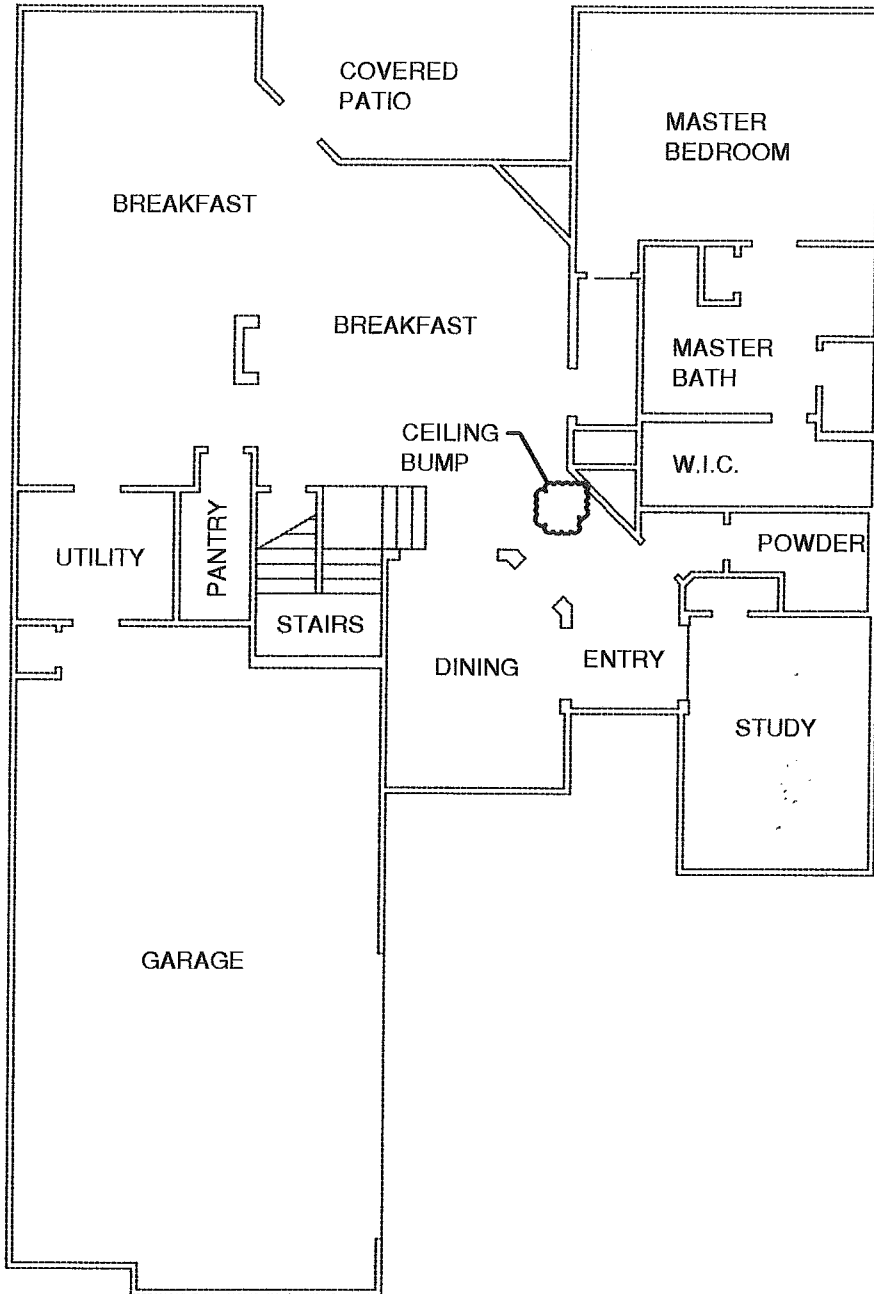
LOWER LEVEL WALLS

- Ceiling separations in upstairs rooms, primarily at the game room.
- Minor nail popouts located throughout house.
- Minor drywall cracks in stairwell and above doorway in guest bedrooms.
- Doors in several upstairs rooms are sticking and are difficult to shut.
- Minor drywall cracking in downstairs walls and ceilings.
- Sheetrock joints visible in the lower level ceiling
- Protrusion in lower level ceiling sheetrock at the dining / entry area

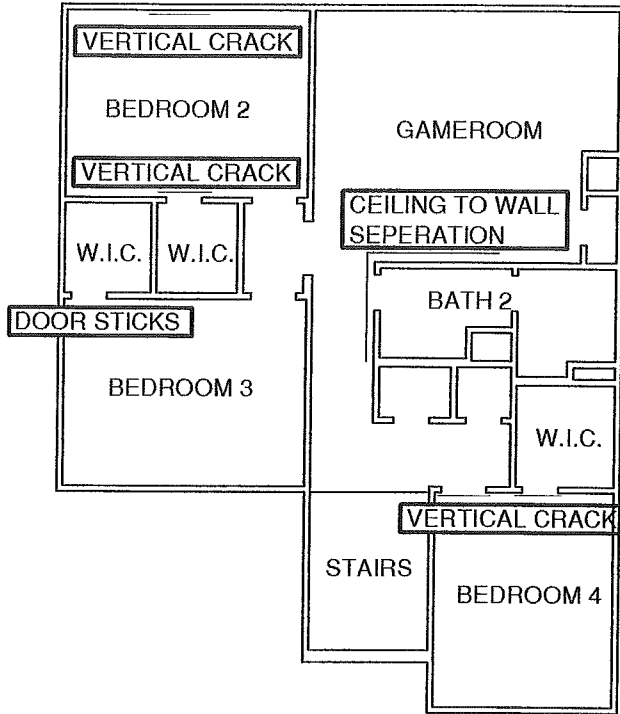
UPPER LEVEL WALLS

1. **Ceiling to wall sheetrock separation (bedrooms, game room areas):** based on our attic observation and review of the relative elevation surveys, we believe that the deflection in the floor system caused sheetrock cracking in the walls and at multiple ceiling to wall interfaces. Although the floor system has approximately 1 inch of elevation drop from the perimeter to the center of the home we believe that most of the deflection existed prior to the application of sheetrock or was "built-in." We make this claim due to the fact that the magnitude of the distress does not appear to correspond with the magnitude of the deflection. The ceiling to wall interface cracking is approximately $\frac{1}{4}$ " wide while the elevation change from the left rear corner of bedroom two to the hallway next to bathroom two is approximately 1 inch. We would like to point out that at least .3 inches of elevation drop is caused by concrete finishing and .1 inches of elevation drop in the compression of the framing. The remaining deflection occurred in the beam (spanning between the family room and the breakfast area) and the floor trusses (spanning from the beam to the walls on either side.) As stated previously, we believe that the beam had .2 inches of deflection and the affected floor trusses (see title heading above) had .2 inches of deflection. The remaining .2 inches of deflection occurred after sheetrock installation and is what caused the distress. To clarify, most homes, with movement or deflection of this magnitude would have cracking much more severe. Therefore, we believe most of the deflection occurred during the framing stage and that minor deflection occurred after sheetrock installation causing the distress that was noted during our investigation.

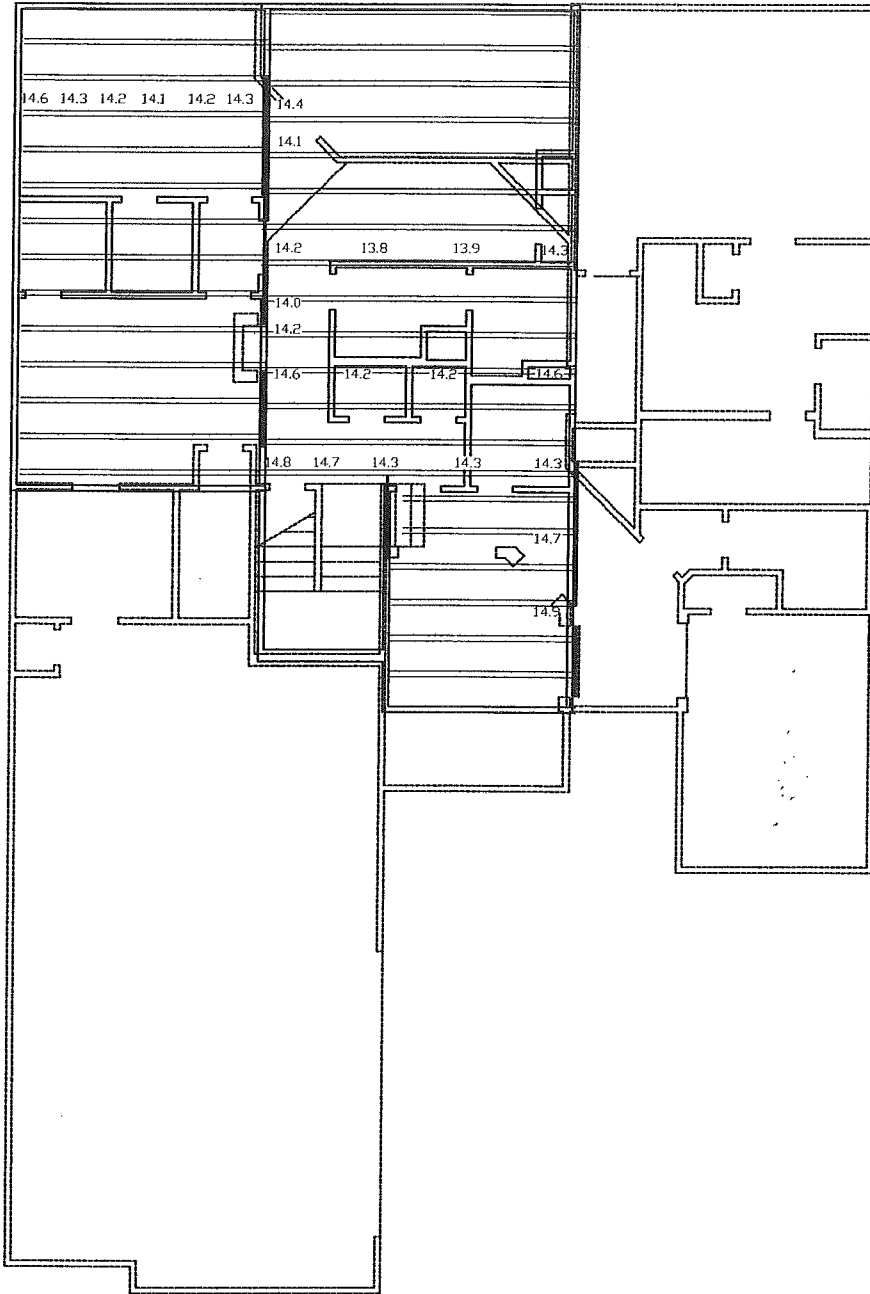
LOWER LEVEL CEILING ELEVATIONS

During our discussion above we did not focus on two other homeowner issues, visible joints in the lower level ceiling sheetrock and a "bump" in the sheetrock at the dining room. Both of these items are considered cosmetic. The "shadows" in the sheetrock are caused by the tape and float process and the "bump" is caused by setting a floor truss hanger slightly below the bottom of a support beam. These items are unsightly but are not considered a structural defect or failure. The next two items are discussed above and the conclusions follow:

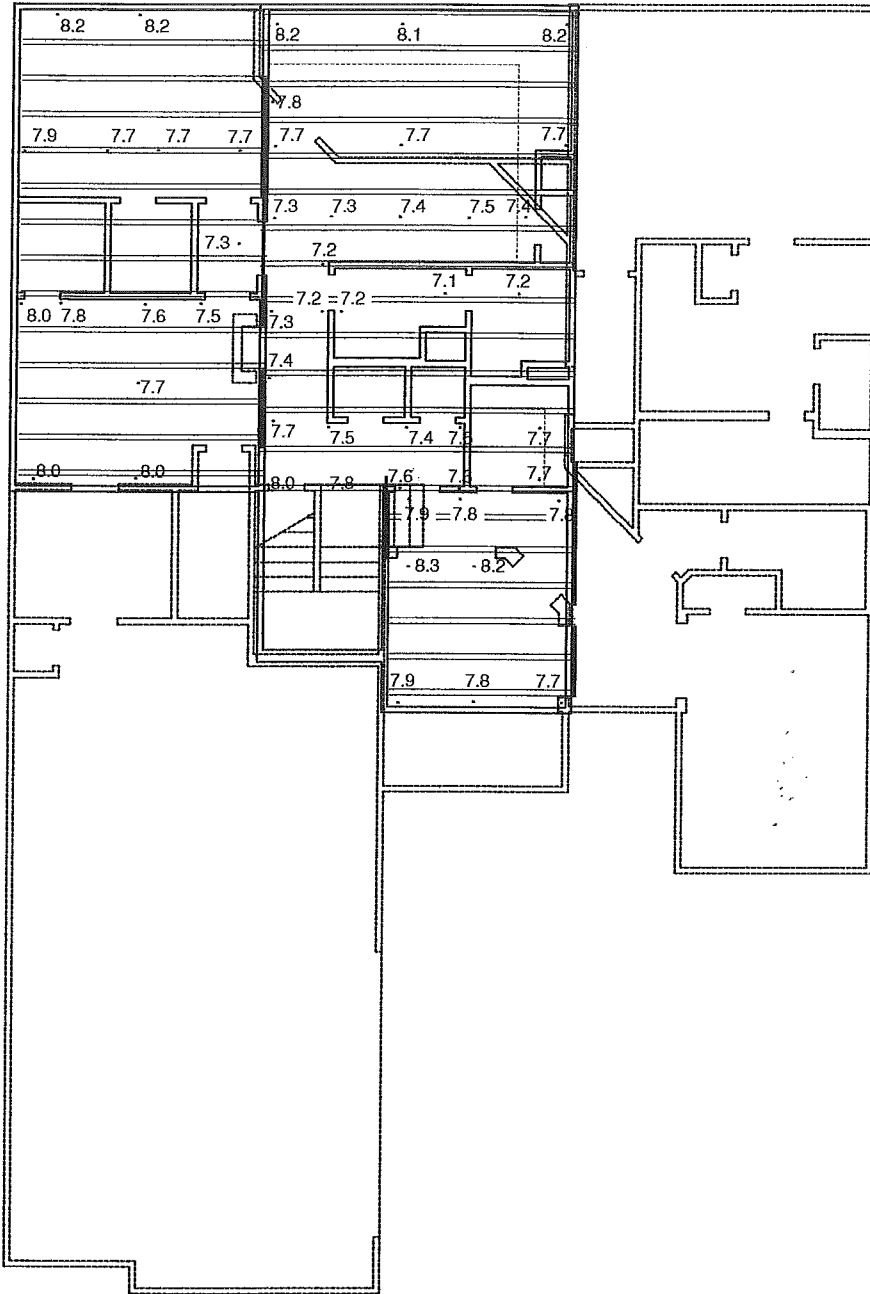
UPPER FLOOR ELEVATION READINGS

2. **Bedroom 4 and roof girder truss T5G:** based on our elevation surveys, observation of the sheetrock at the dining room and observation of the sheetrock at the (rear most) wall of bedroom 4 we believe that the floor system is overloaded. After much study, investigation and consultation with the builder and truss supplier we have determined that the girder truss that spans across the width of the home is overloading the floor system. The current configuration of the roof trusses are shown on the attached upper level ceiling drawings. In the current configuration the T5G uses the wall of bedroom 4 as a bearing point which transfers significant load into the (2) 2x12 below which is supported by a floor truss. It is this floor truss that has the hanger / sheetrock issue noted by the homeowners at the dining room area. We have a repair drawing for this truss to change the bearing location to a stacked wall thus alleviating the load to the floor system, see attached T5G detail. This overloading is causing the deflection in the floor system as noted when walking out of bedroom 4 into the hallway.

1. We believe that the home was constructed with existing deflection. Although the degree of deflection is difficult to ascertain we surmise that .6 inches of deflection had occurred prior to sheetrock installation. We believe that .3 inches occurred in the concrete finishing, .1 inches occurred in the compression of the framing at the beam bearing location, .2 inches occurred in the beam and .2 inches occurred in the floor trusses. The remaining deflection occurred after sheetrock installation thus causing the distress noted. Keep in mind however that the deflection values listed above are based on judgment and others may differ in their opinion. We believe refinishing the distress in the upper level sheetrock and re-setting the affected doors would be the most prudent action at this time. We would like to monitor the deflection of the upper level after the repair over the next year.
