Subject: Forensic Report TFE1148
Ron and Carol Hemphill Residence
240 Canterbury Drive
Austin, Texas 78737
Claim No. 53-F310-595

Hemphill Residence
Claim No. 53-F310-595

Introduction

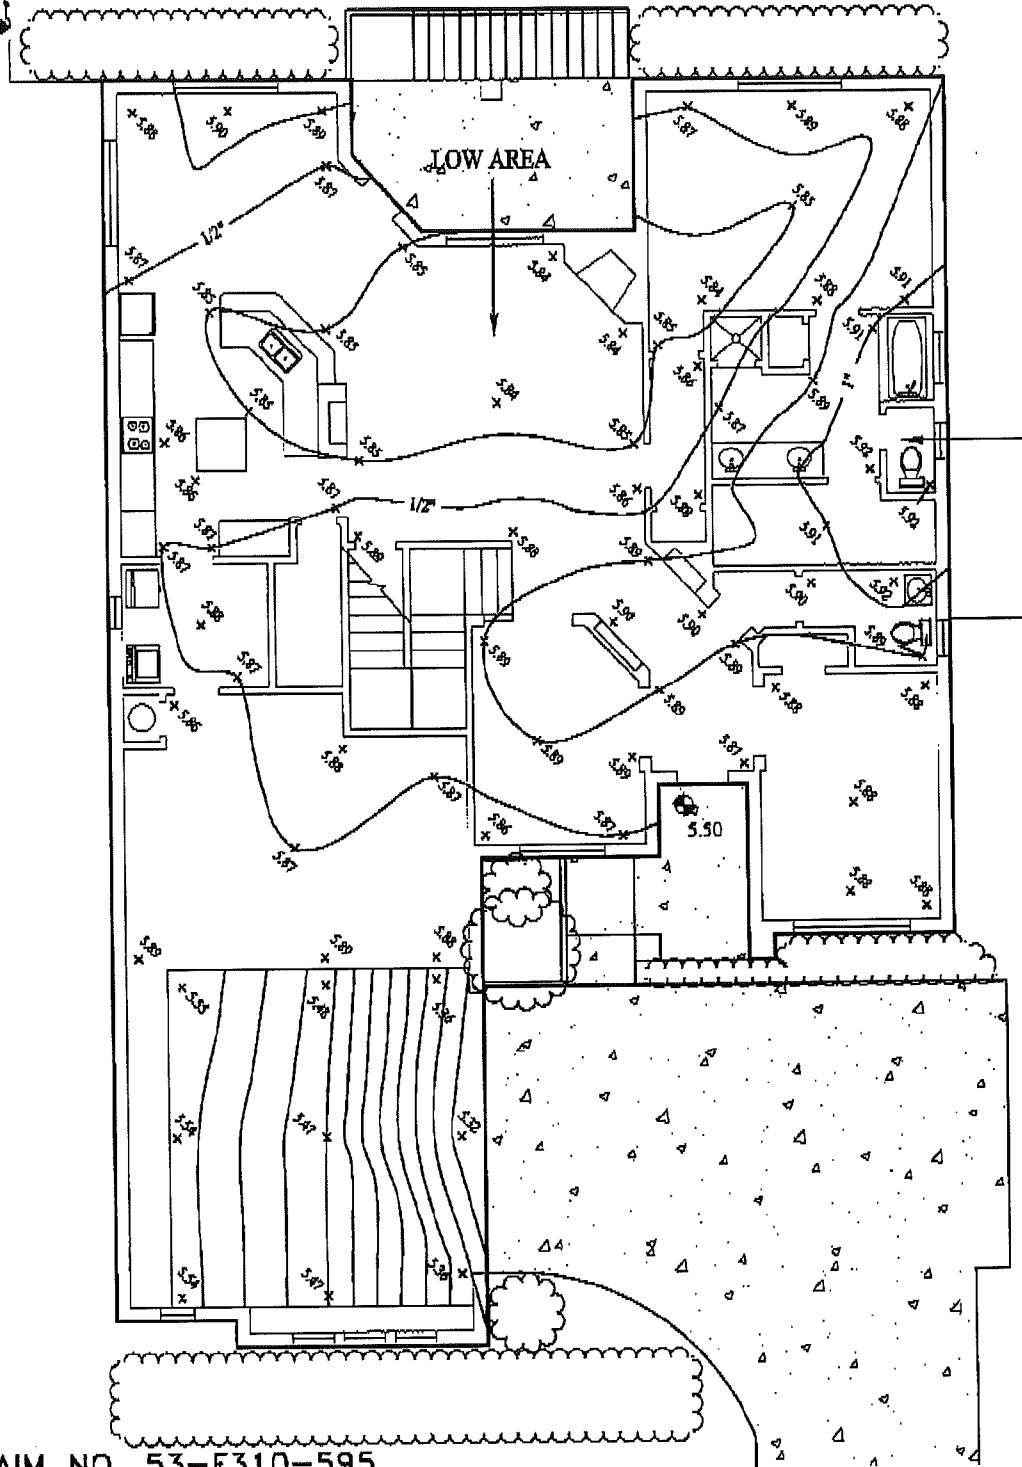
PROJECT NO. TFE1148
SHEET 3

As indicated on Sheet 3 of Exhibit B, the highest elevation (5.92 feet) was measured at the master bathroom, while the lowest elevation (5.84 feet) was measured at the family room, for an overall difference of approximately 0.08 feet or one inch. The garage varies approximately 2-3/4 inches from west to east. The generated elevation contours describe a pattern of higher elevations at the master bathroom area and slightly lower elevations throughout the family room. A portion of the measured elevation differences can be attributed to originally-constructed conditions.

Based on our site observations, the current 1st floor elevations, and our review of the available information, we find that the foundation system is performing favorably and in accordance to its intended design. The current floor elevations confirm consistent elevations across the slab, with an overall elevation difference of about one inch from the master bathroom area to the family room. These elevations and slope patterns are consistent with those presented by MLAW Consultants and Engineers (May 2007), Nelson Engineering (August 2007), and Amstar Engineering, Inc. (November 2008). The documented elevations and slopes are not considered a factor contributing to the structural framing conditions or finish distress that has been documented.

6. Remedial foundation repairs are not warranted or recommended at this time. We do recommend monitor the performance of the foundation and structure through distress documentation and periodic floor elevation surveys. Any remedial foundation repair measures considered in the future should be implemented under the direction of a licensed professional engineer and in accordance to the Guidelines for the Evaluation and Repair of Residential Foundations, as presented by the Texas Section of the American Society of Civil Engineers.

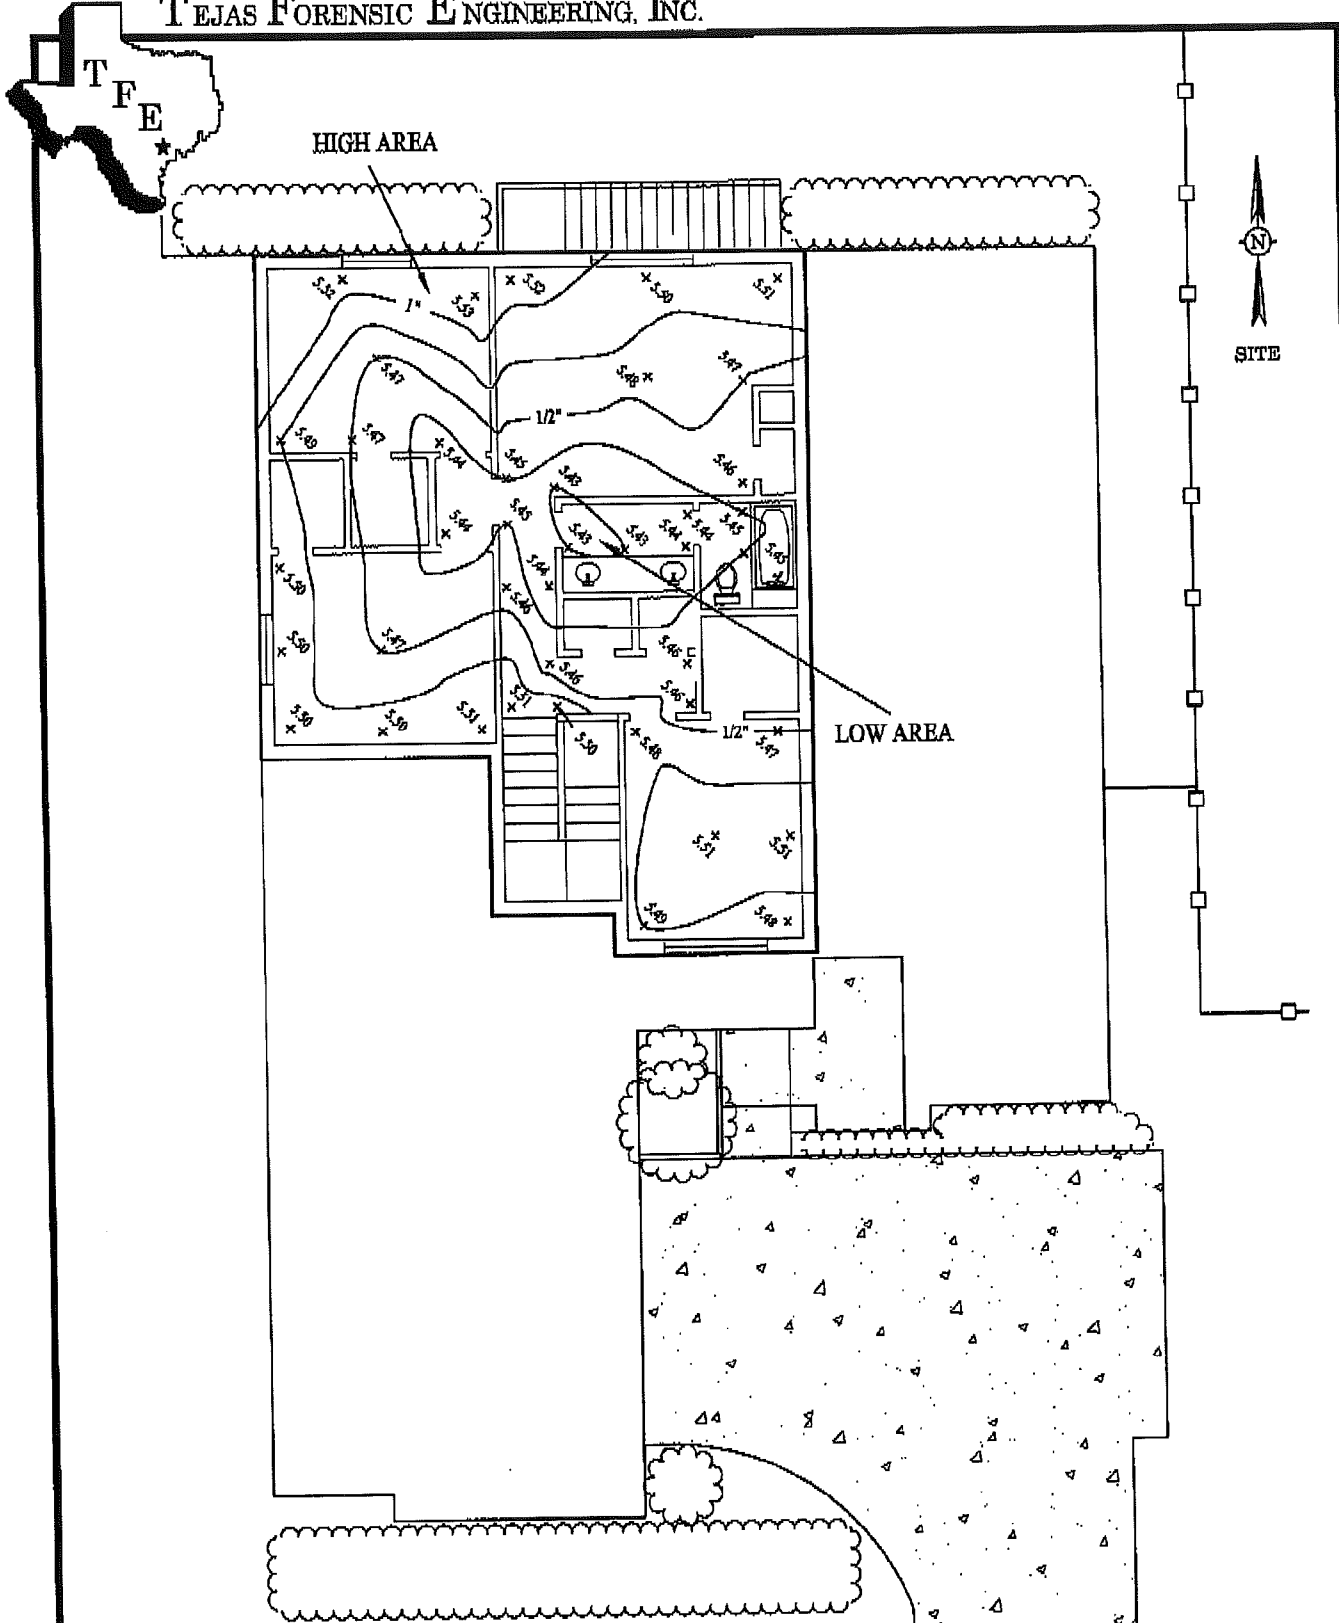
HEMPHILL	2ND FLOOR ELEVATIONS	PROJECT NO. TFE1148
DATE: 02-02-09	SCALE: 1"=10'	SHEET 4

Similarly, the second floor elevations were completed by assuming a benchmark elevation of 5.50 feet at the stairway landing. According to Sheet 4 of Exhibit B, we confirmed an overall elevation difference of 1-1/4 inches, as measured from 5.53 feet along the north side of bedroom #3 to 5.43 feet at the bathroom #2 doorway. The generated elevation contours depict general downward slopes toward the hallway/bathroom #2 area.

The current floor elevations and slopes presented on Sheet 4 of Exhibit B do confirm that measurable floor system deflection has developed since original construction. The magnitude of the deflection is considered excessive and its primary cause has been studied extensively, with the most comprehensive findings being presented by Amstar Engineering, Inc. in their report issued on November 20, 2009. Amstar Engineering, Inc. has clearly identified structural framing conditions which have existed since construction, and which account for the resulting floor

1. The structural framing conditions which have been confirmed by Amstar Engineering, Inc. are the primary cause of the 2nd floor system deflection and the resulting finish distress. In our opinion, any external loading imposed to the roof system during the winter storm conditions in January 2007 was not significant and did not contribute to the pre-existing finish conditions that were reported to the builder by the homeowner.
2. The structural framing conditions confirmed by Amstar Engineering, Inc. are considered hazardous and should be mitigated as soon as possible.
3. The foundation system is performing favorably and in accordance to its intended design. The current elevation differences and slopes are considered typical for similar structures constructed on active soils.

1. Retain the services of a qualified contractor to address the structural conditions which have been reported by Amstar Engineering, Inc. All work should be completed in accordance to local building code requirements, and under the direction of a licensed professional engineer.
2. Repair the impacted finishes upon completion of the structural repairs.
